## **E-Krete™ Polymer Composite Micro-Overlay for Airfields: Laboratory Results and Field Demonstrations**

J. Kent Newman and James E. Shoenberger

November 2003

Final report

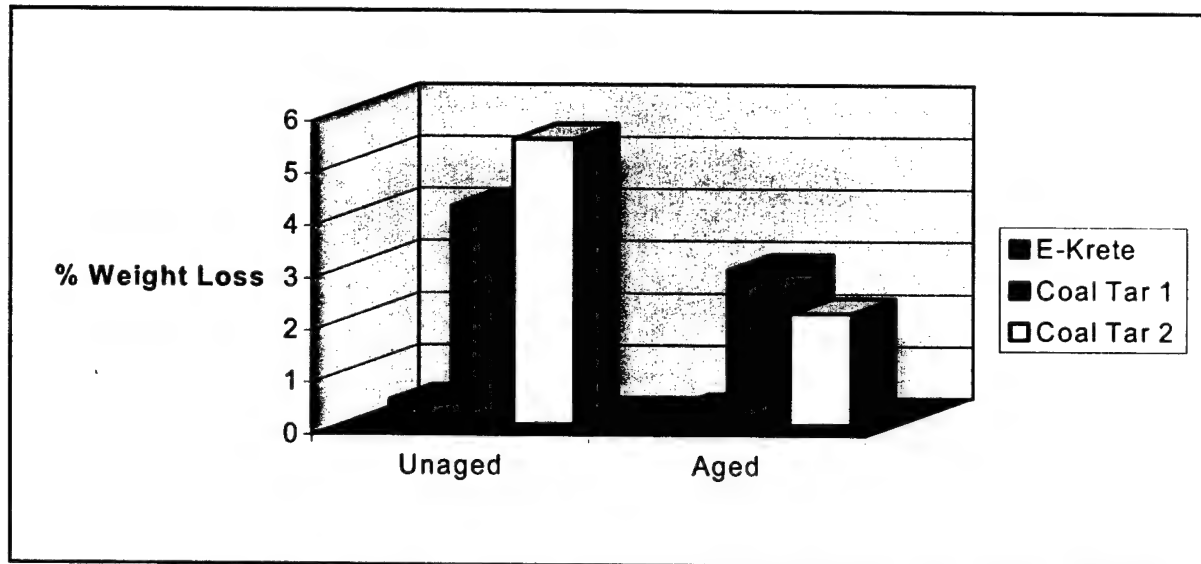
The results of the abrasion testing indicate that the unsealed E-Krete™ material is approximately 8 to 10 times more abrasion resistant than a standard coal tar emulsion. The sealed E-Krete™ is approximately two times more abrasion resistant than the CTE. The difference between the sealed and unsealed E-Krete™ indicates that the surface sealer is abraded more rapidly than the E-Krete™ base. Although the abrasion resistance of the CTE's is higher after aging because of the embrittlement, it is well documented that these materials exhibit severe "chicken-wire" or "map" cracking with age and must be resealed every 3 to 6 years (Shoenberger 1993 and Saraf, Majidzadeh, and Kumar 1992). There is no statistical loss in abrasion resistance after aging of the E-Krete™ material. The reduced variation in the test results for E-Krete™ indicates the consistency of the product.

Figure 1. Abrasion resistance of E-Krete™ compared to coal tar emulsion using a modified form of the wet track abrasion test
